December 17, 1998

Site Inspection, San Rafael Energy, Inc., Probe Mine, S/015/011, Emery County, Utah

Purpose of Inspection: To examine the reclaimed mine site and shaft closures in consideration of

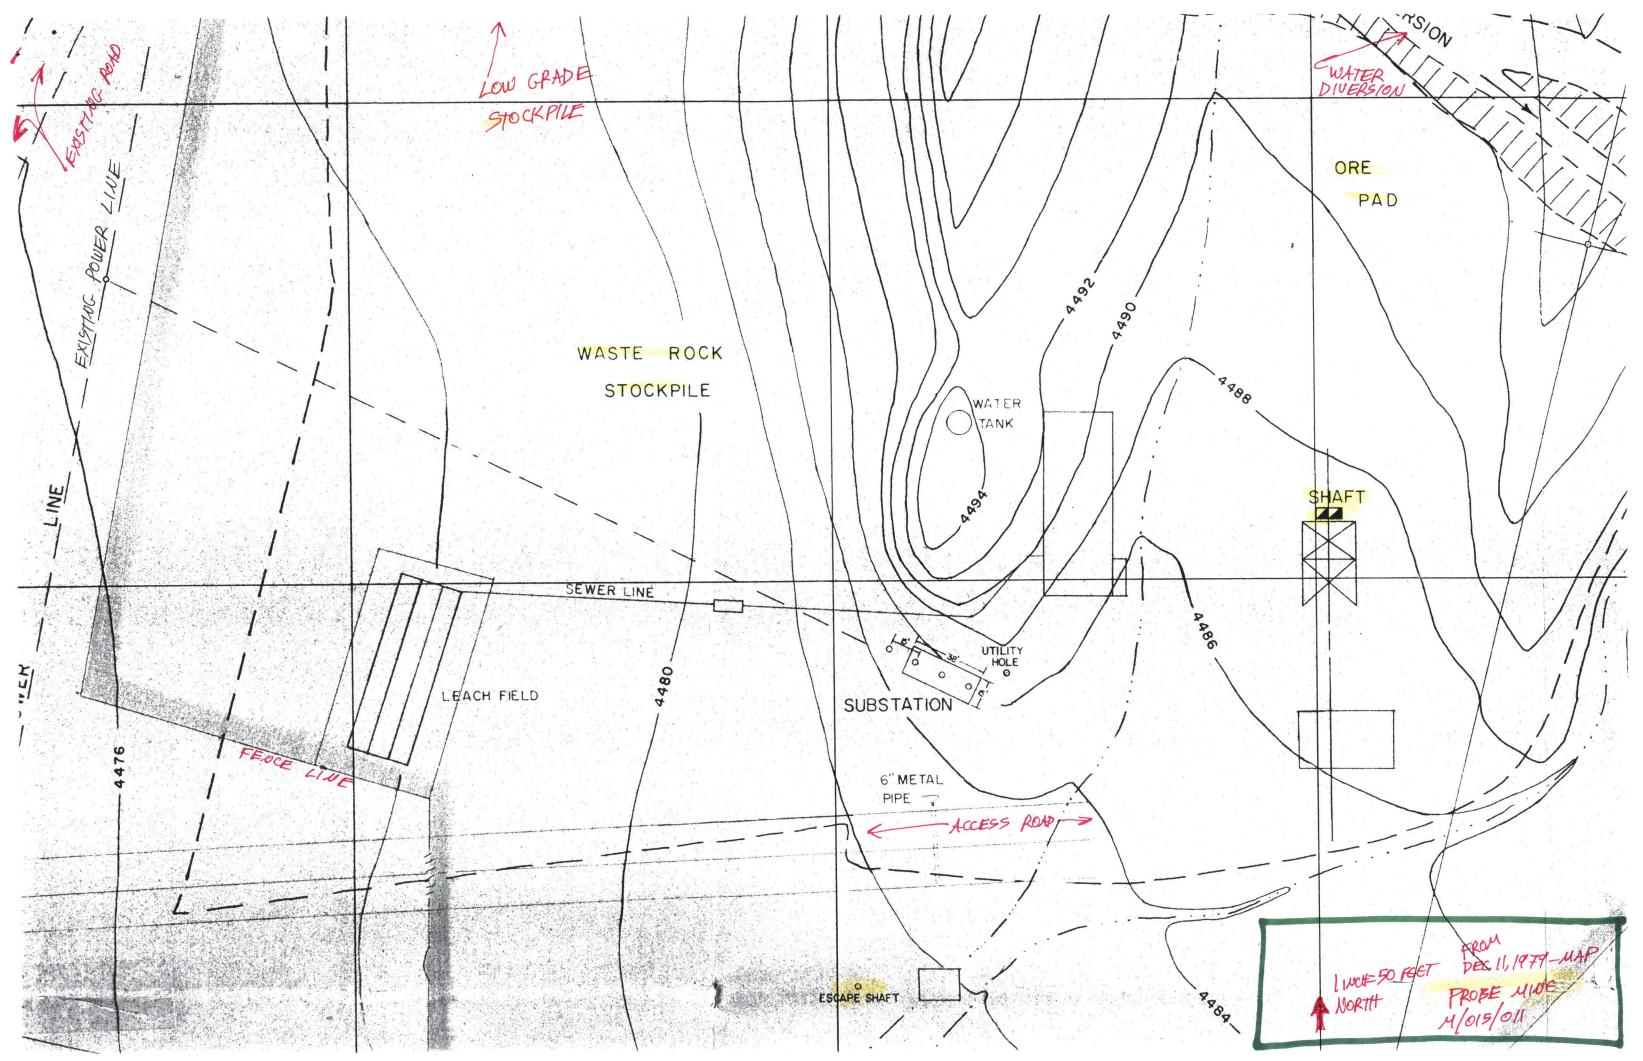
S/015/011 PROBE MINE

The inspection began at the southern edge of the angle of repose mine dumps. Photos were taken of the dumps looking north at the mine area. Visible in these photos is a line of mounded waste material over the access road. From the southern edge I walked around to the east end of the mine site. All structures have been removed from the site. There were some desirable plant species on portions of the pad area, mainly indian ricegrass. Plants are generally located in areas which have topsoil mixed in or with topsoil covering the waste material. Most of the plants on the pad area are russian thistle and halogeton. Additional photos looking toward the west show the reclaimed access road and waste dump.

There is very little vegetation on the waste rock dump. Photos were taken looking toward the south -southeast showing the top of the waste rock dump. The dump top was graded toward the east with the west facing dump slopes left at the angle of repose. One unusual feature at the site was a rectangular area of vegetation. Photographs were taken of this vegetation located on the south side of the waste dump between the dump and the reclaimed road. This area may have been a drainage field or leach field associated with the mine operation.
